# Reactions that occur at the surface of the part during nitriding

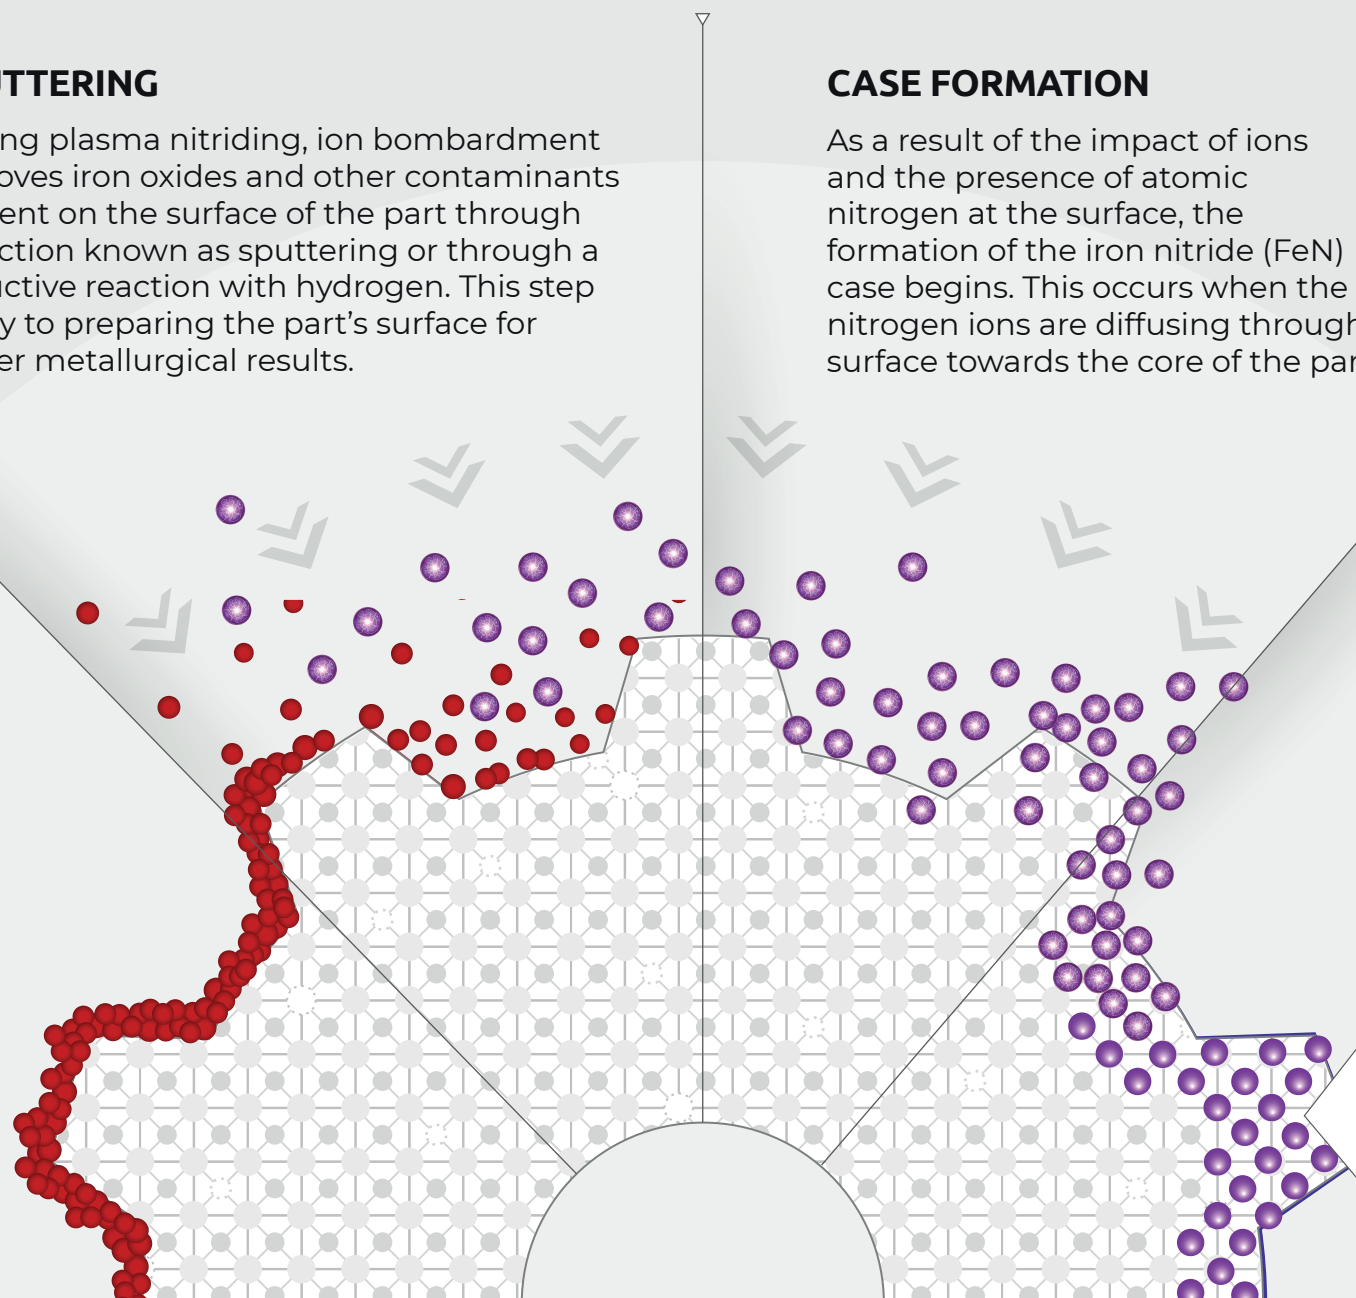
## The result:

The result: a layer of iron, mainly (Fe<sub>3</sub>N and Fe<sub>4</sub>N), and other nitrides, which is a kind of ceramic mantle with low friction coefficient, higher corrosion resistance and high hardness.
